# Preliminary Review of Coastal Conditions at Woodland Beach Tiny Township, County of Simcoe

August 10, 2008

## **Woodland Beach Site Visit**

### **Tiny Township, Simcoe County**

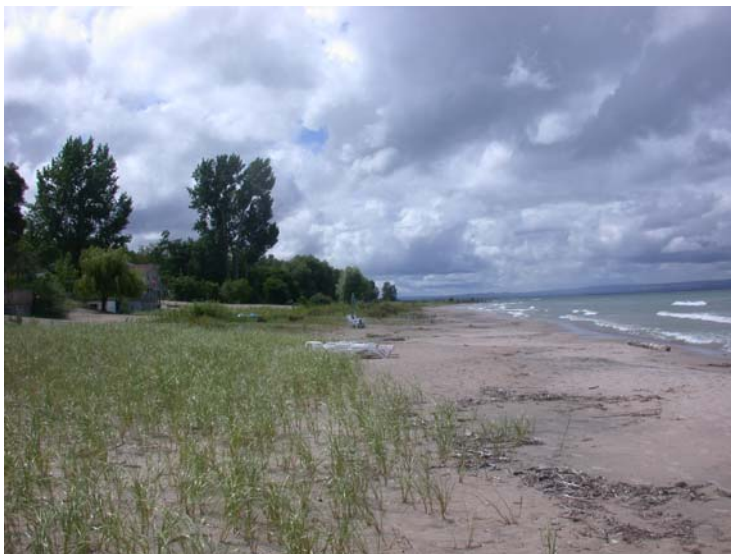
0.5 km north – creek outlet onto the beach between cottage #2096 and #2100 and located approx. 60 m south of South Street

1.0 km north - The Township park (#2020) with parking and washrooms at the west end of Lawson Road

1.5 km north - King's Rock where the beach narrows and the bluffs begin

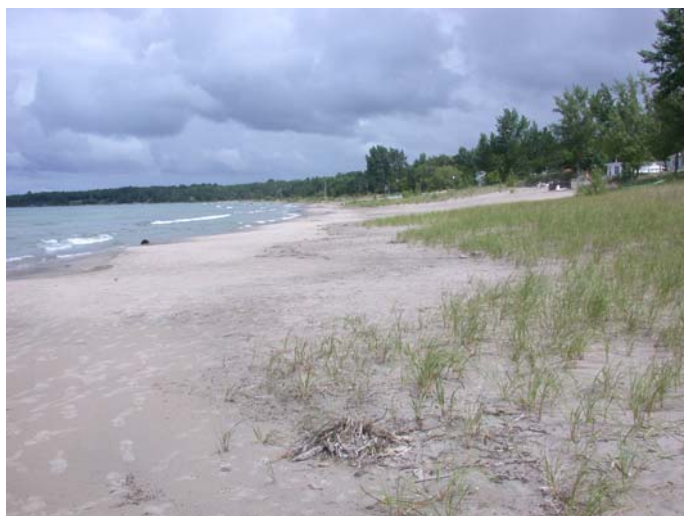
Beach characteristics – several lots (approx # 2130 to #2146) appear to have limited vegetation and many lots bulldoze the sand away from their cottage. Embryo dunes are in existence and several cottages have dune grass well established.

Vegetation – American Beachgrass (*Ammophila breviligulata*) is the dominant dune plant where dunes exist. Areas where dunes have been altered by bulldozing exhibit a deflated profile compared with vegetated dune areas.

*Recommendation – If it is possible, recruit a cottager who has practiced poor stewardship practices to undertake a demonstration project intended for sand management and the control of sand drifts. Beach Association members could volunteer to assist with beachgrass planting and sand fence installation. The Coastal Centre can provide awareness signs to help promote education and awareness. This could be framed as a project of the Association to support a fellow member with sand control issues. A demonstration project will allow other cottagers to witness the progress and results, and encourage others to consider similar measures.*

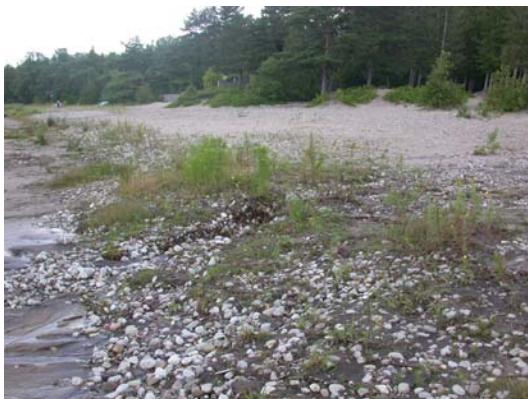
Cobble beach with sand veneer at the upper portion of the beach.

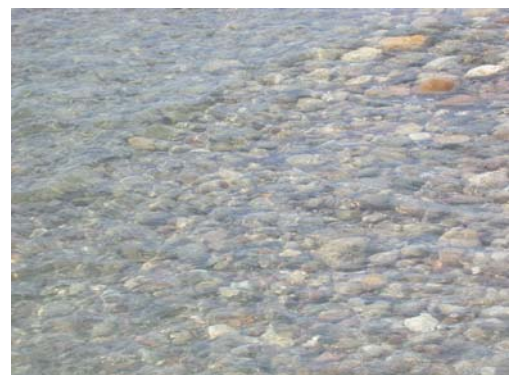
Nearshore cobbles forming a protective armouring of the shoreline.

*Recommendation – Educate members about the significance of cobble beaches and their role along the coast. Not only do they provide habitat for numerous plants and animals, but they provide important armouring of the shoreline that helps protect cottages during high lake levels and storms. Removal of the armouring can create erosion conditions.*
